DOT/FAA/AR-96/21

Composite Failure Analysis Handbook Update 1

August 1997

Final Report

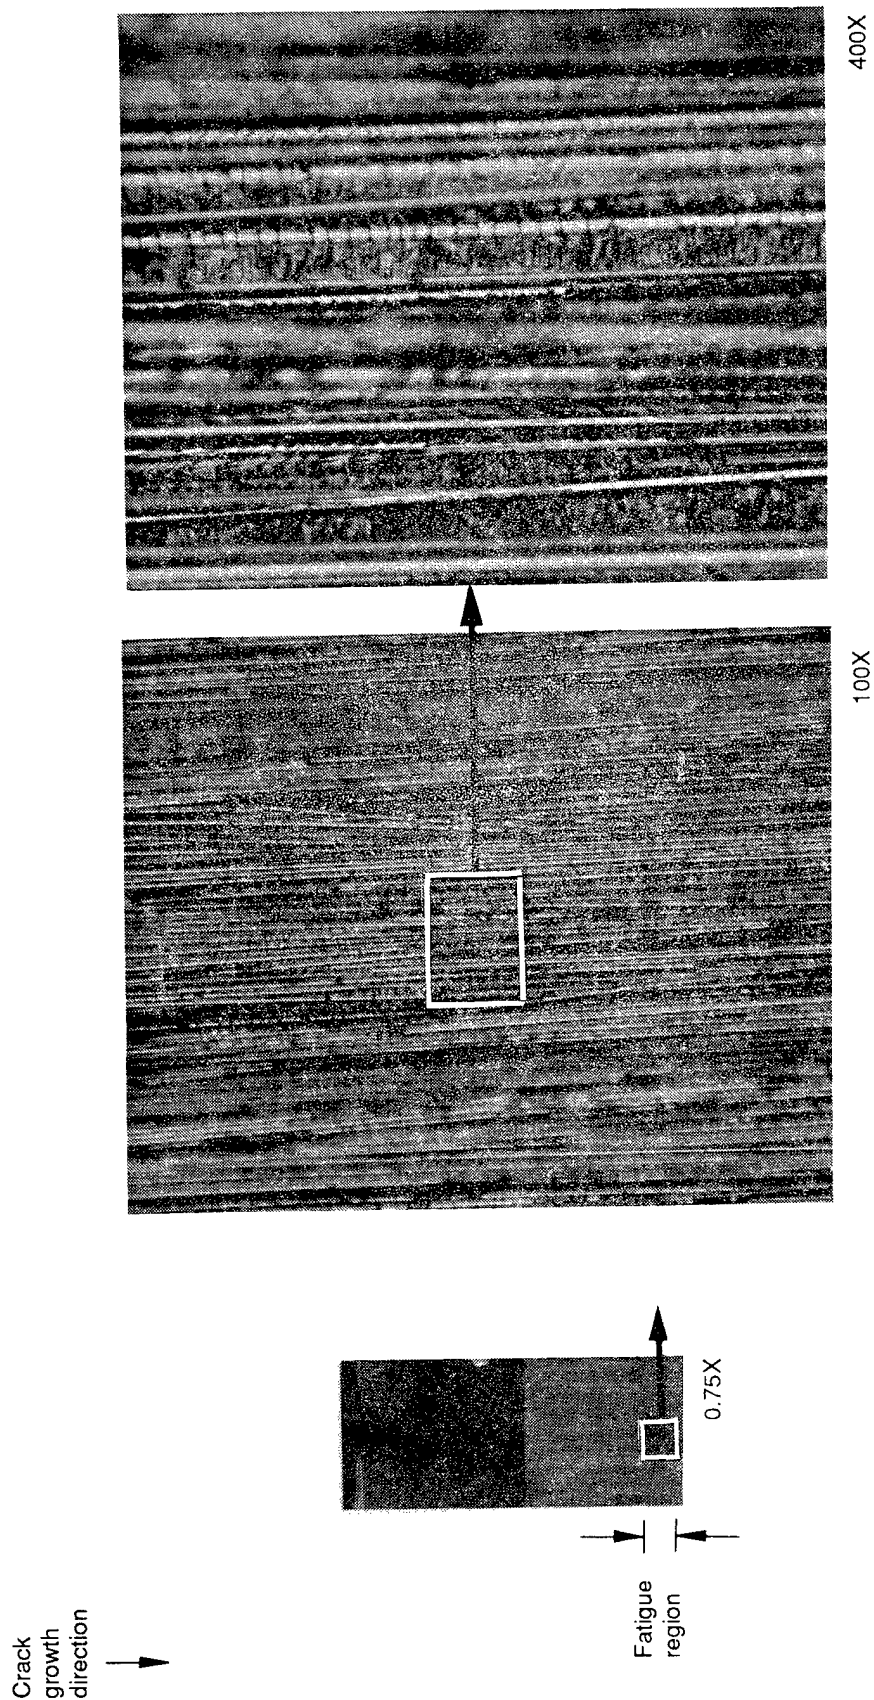
The typical mode II crack propagation features were easily identified on the surfaces of both specimens. In addition, indications of fatigue loading, in the form of fatigue crack growth increments or striations, were visible on the low-stressed specimen. They were observed only on the exposed fibers at the high optical and SEM magnifications. Even though the high-stressed fracture surface was thoroughly examined, no striations were found. Figures 3.1-1 through 3.1-4 show optical and SEM fractographs of interlaminar mode II fatigue at high and low stress levels.

Figure 3.1-1. Optical Fractographs of 3501-6/AS4 Interlaminar Mode II (Shear) Fatigue, Low Stress Loading, 270°F

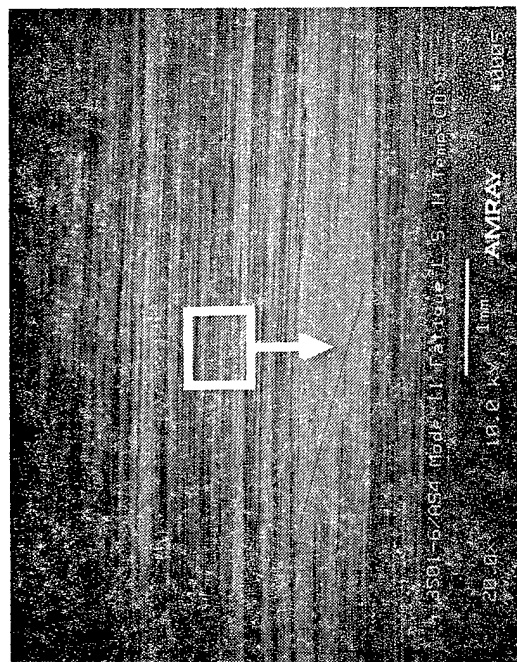
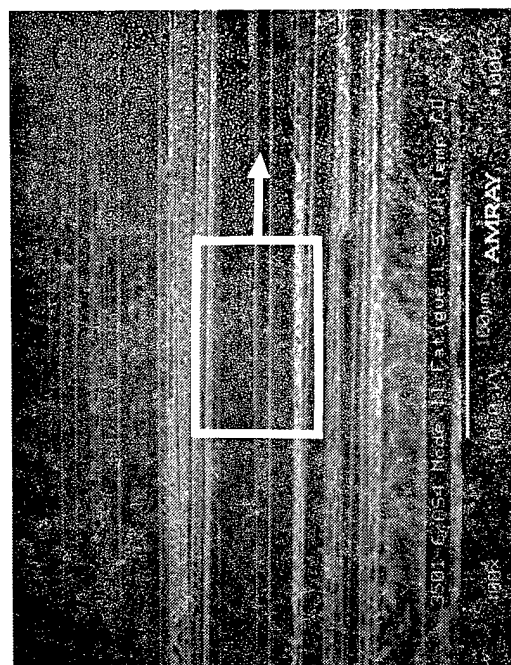
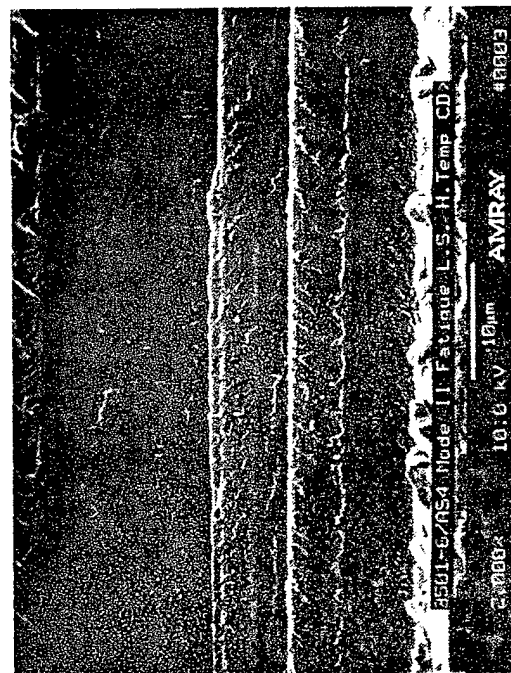
Figure 3.1-2. SEM Fractographs of a 3501-6/AS4 Interlaminar Mode II (Shear) Fatigue Fracture Surface, Low Stress, 270°F

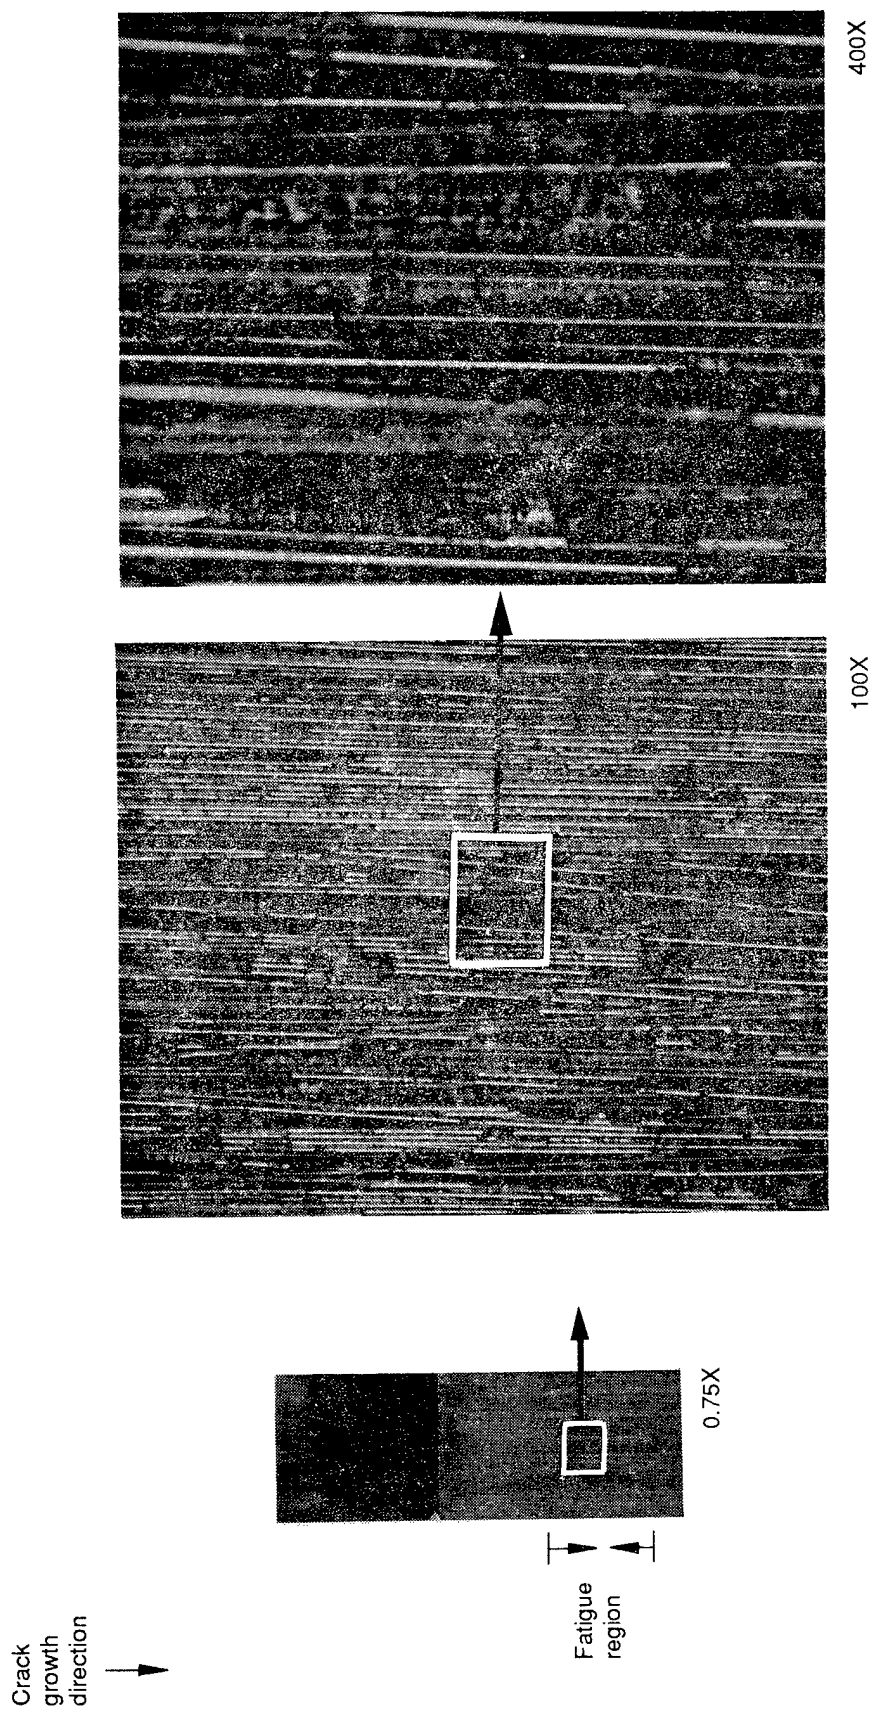
Figure 3.1-3. Optical Fractographs of 3501-6/AS4 Interlaminar Mode II (Shear) Fatigue, High-Stress Loading, 270°F

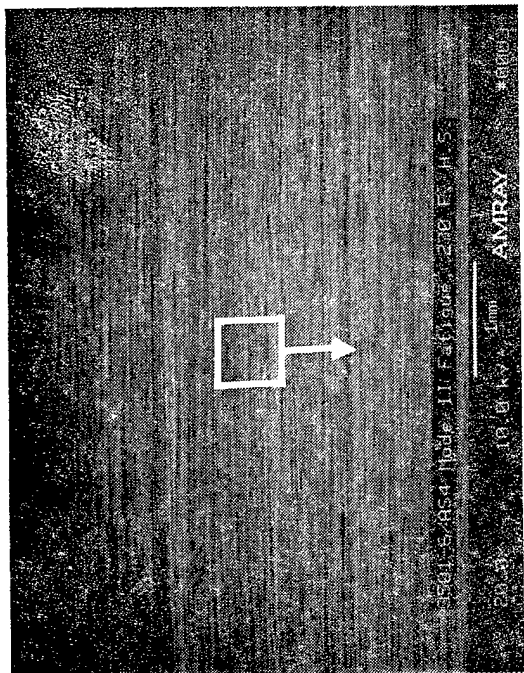
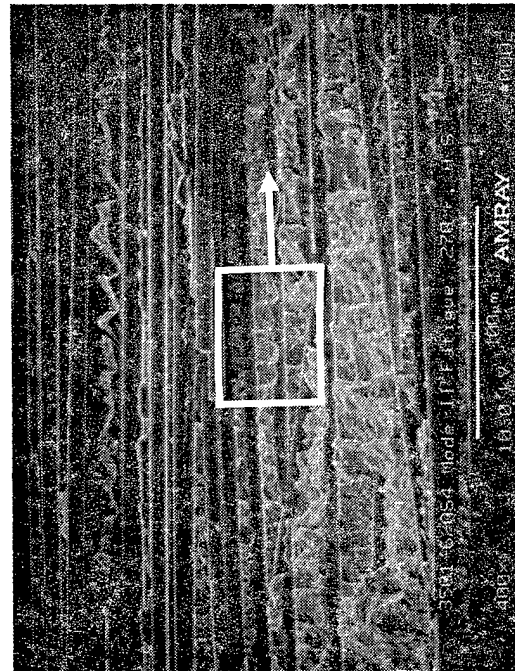
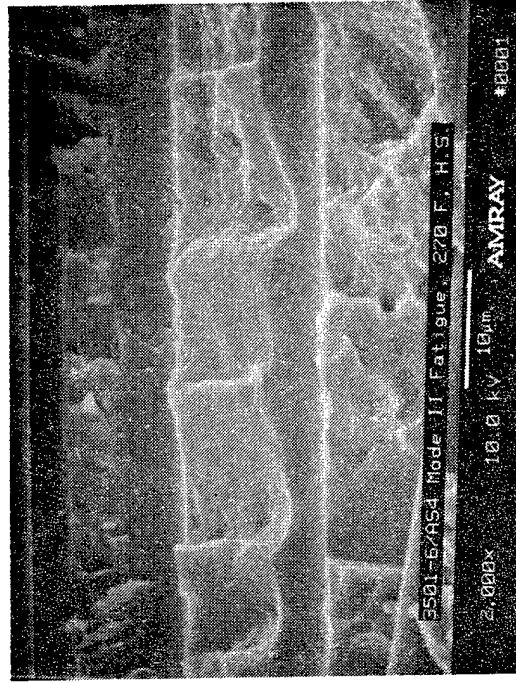
Figure 3.1-4. SEM Fractographs of a 3501-6/AS4 Interlaminar Mode II Fatigue Fracture Surface, High Stress, 270°F

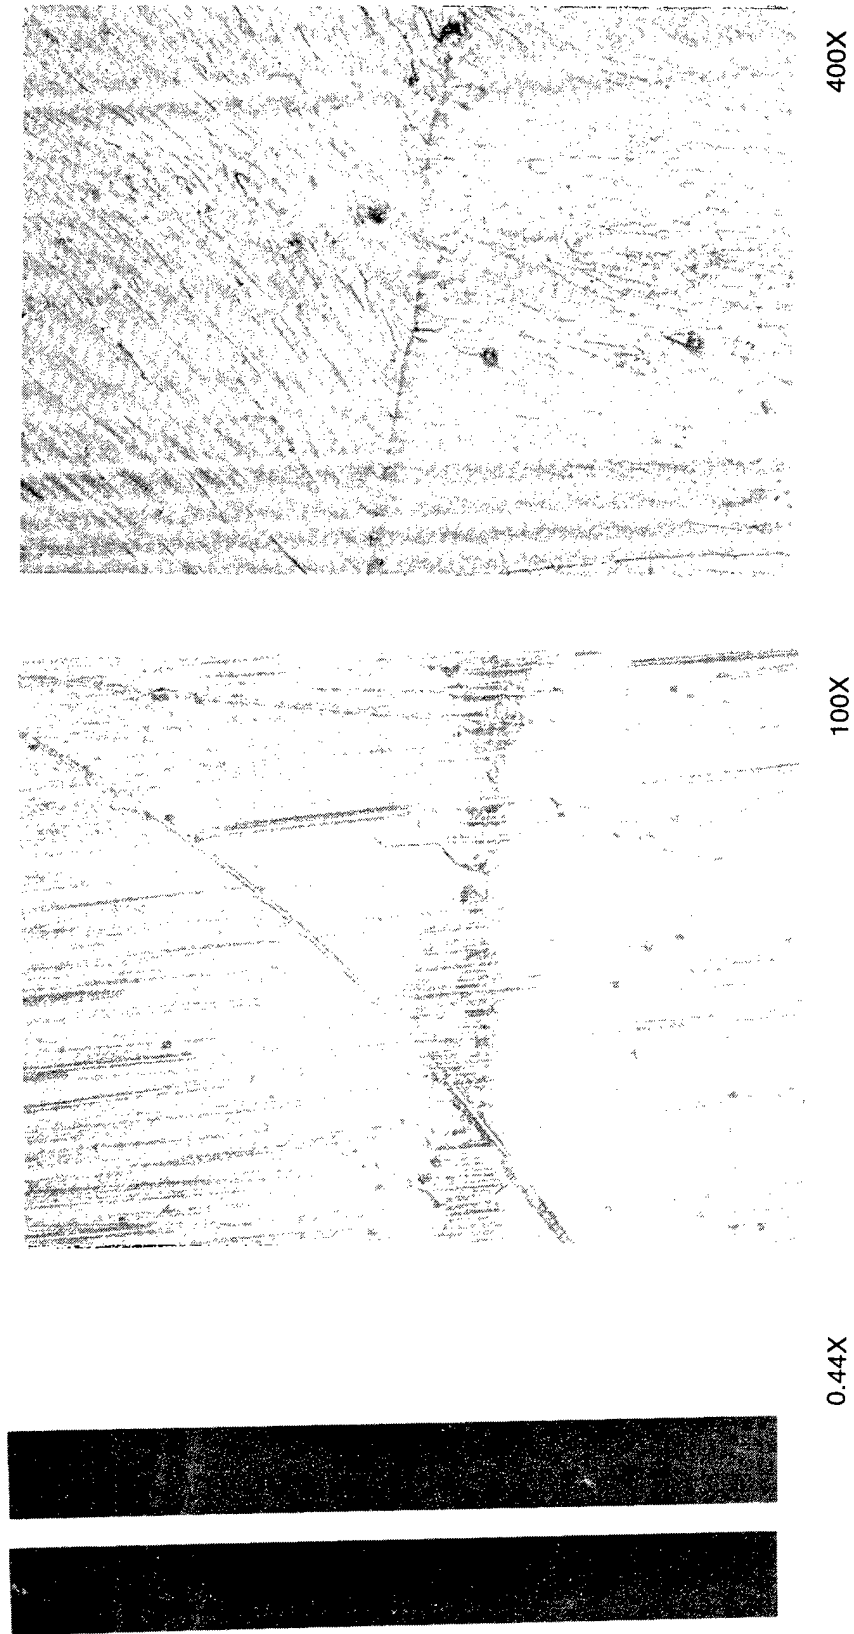
The mode I crack propagation features were not easily seen on the fracture surfaces (Figures 3.1-5 & 3.1-6) unlike a typical static load fracture surface. There were more features indicative of mode II (shear), such as hackles, throughout the surfaces. But these corresponded to the fiber pullout fractures than the overall crack propagation. Neither did these features generally indicate the overall crack propagation direction.

Figure 3.1-5. Optical Fractographs of a 3501/AS4 Interlaminar Mode I (Tensile) Fatigue Fracture Surface, 270° F

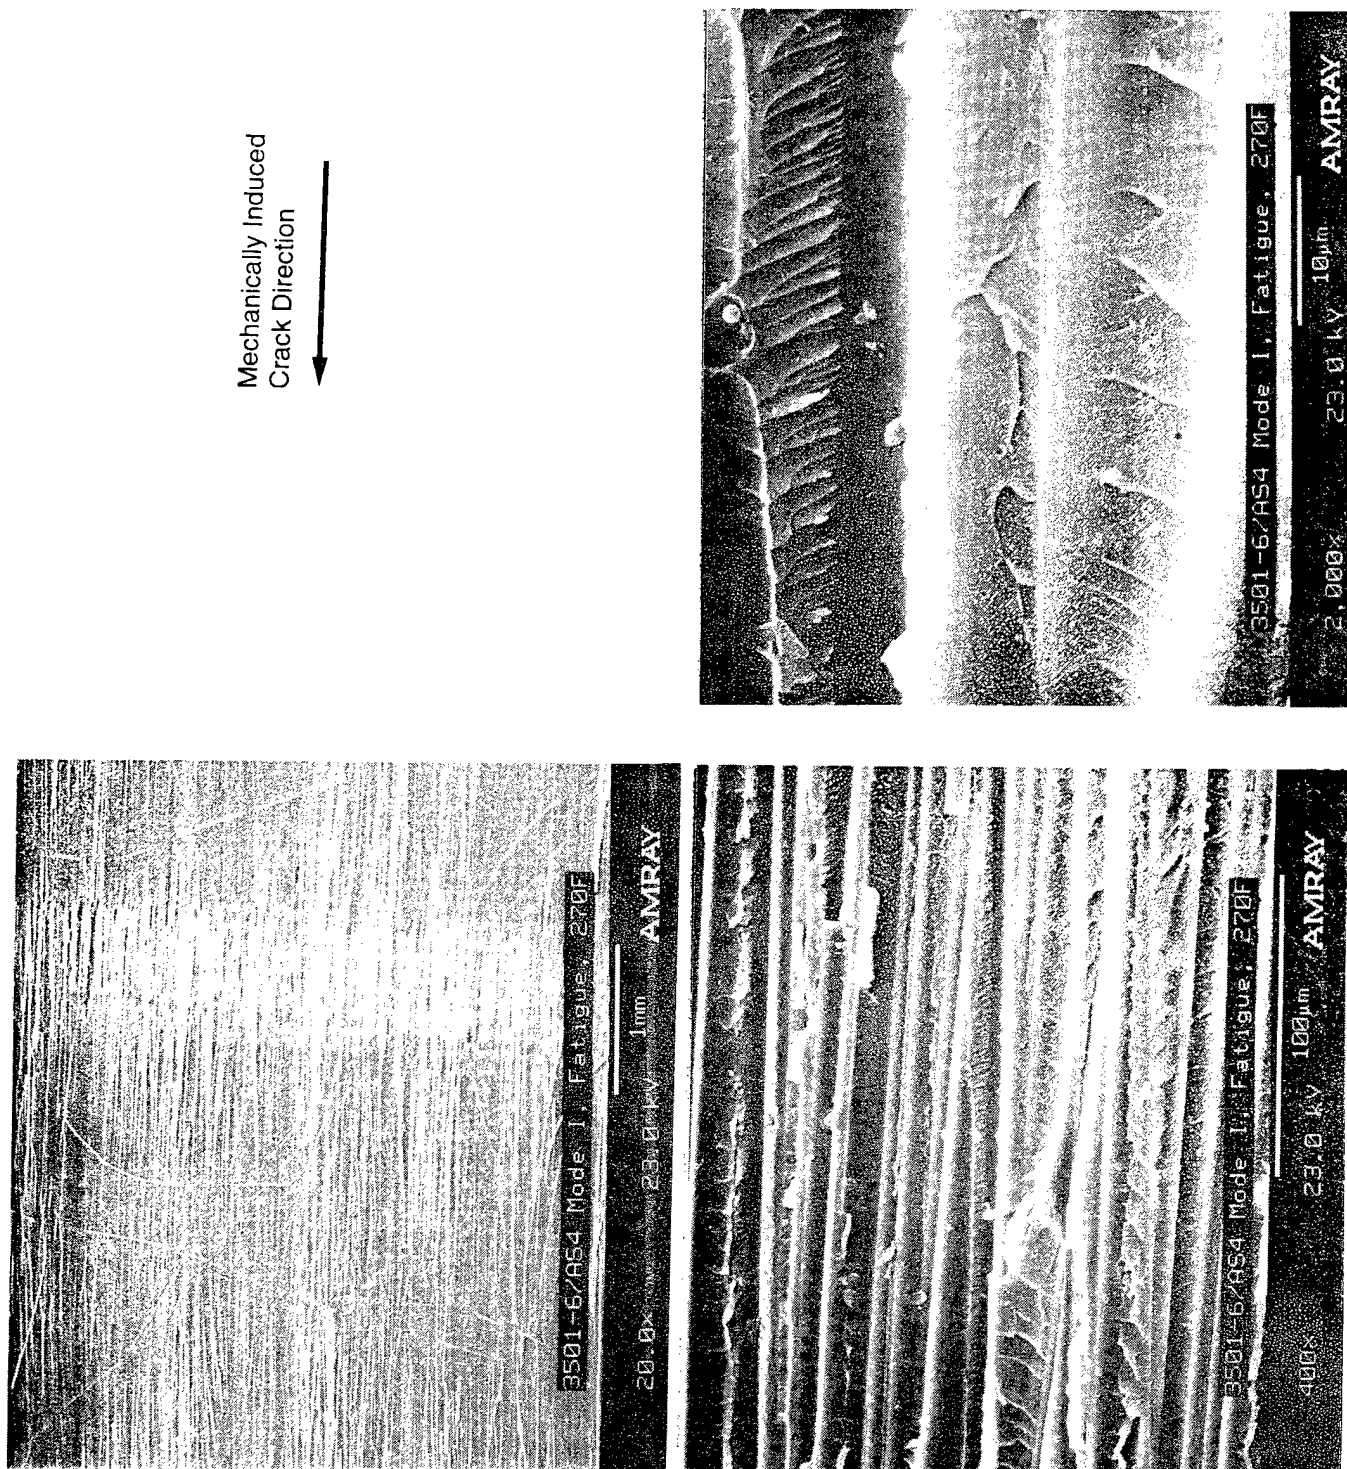
Figure 3.1-6. SEM Fractographs of a 3501/AS4 Interlaminar Mode I (Tensile) Fatigue Fracture Surface, 270° F

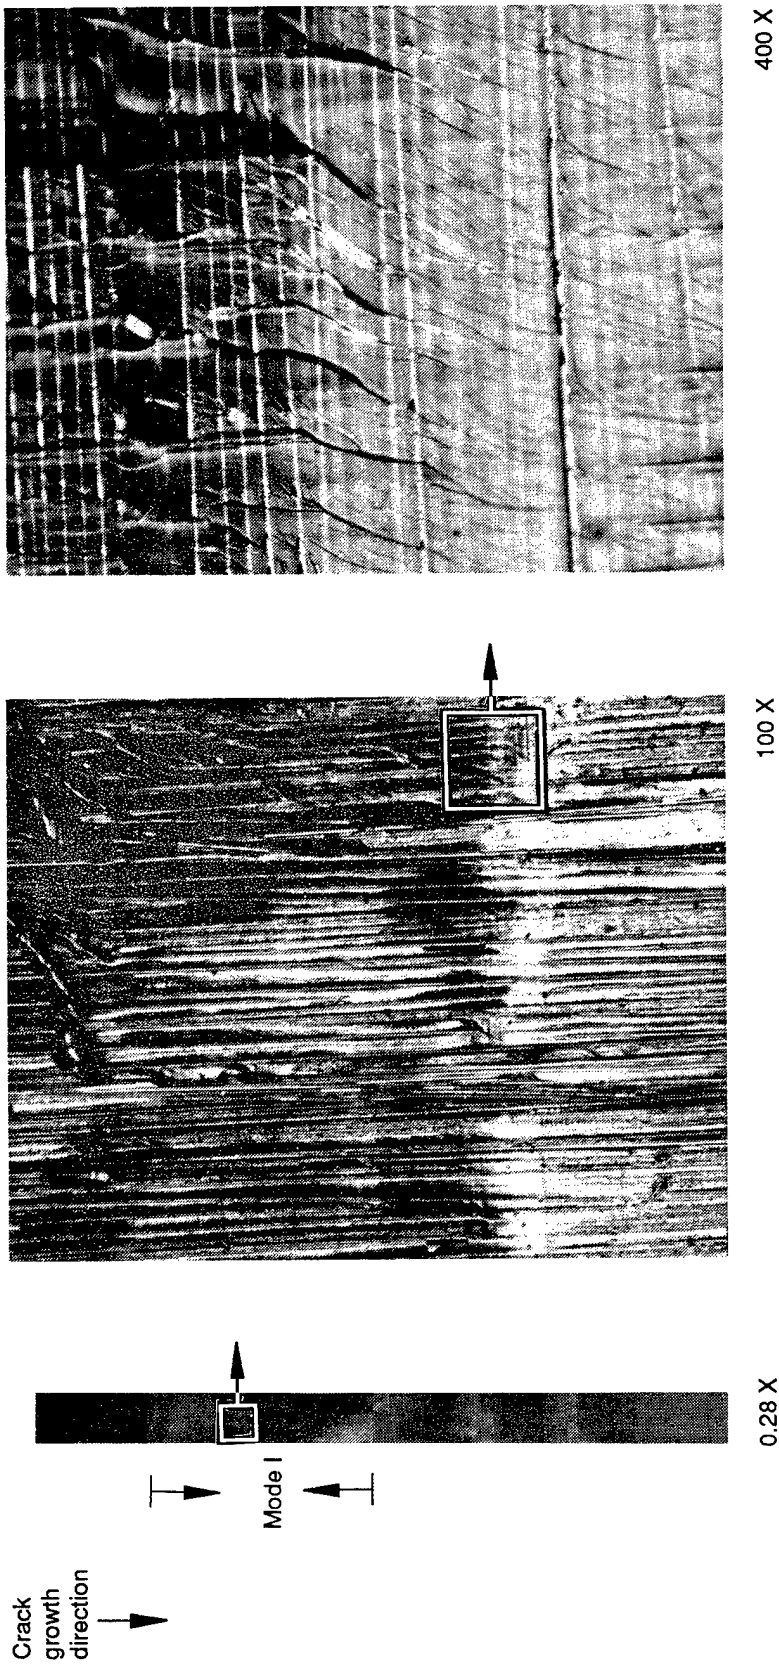
Following the exposures, the specimens were then tested and examined. Fractographic analysis of the surface morphologies revealed no abnormal or unusual surface features on any of the specimens.

Figure 3.1-7. Optical Fractographs of 3501-6/AS4 Interlaminar Mode I Tension, Specimen Exposed to Deicing Fluid

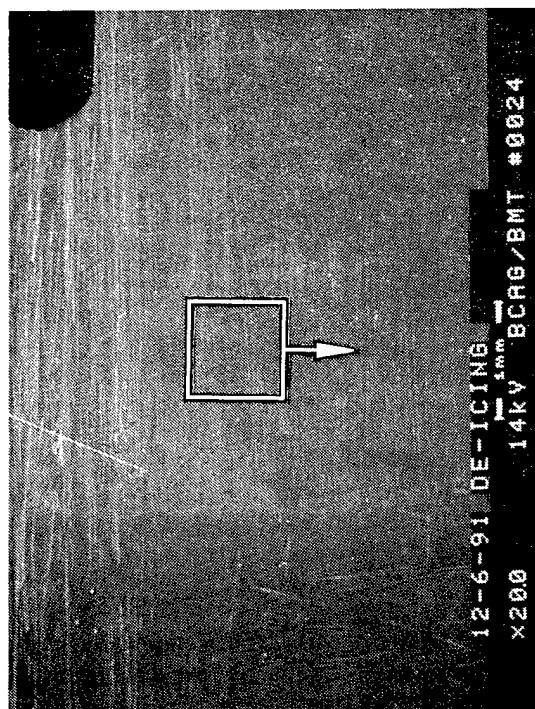
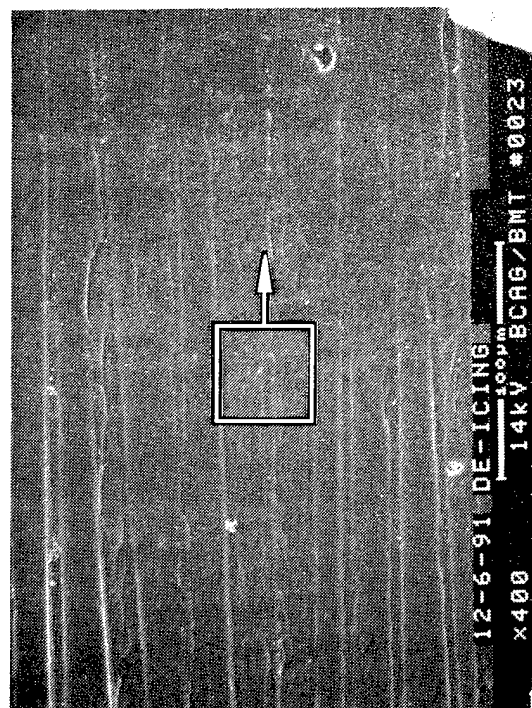
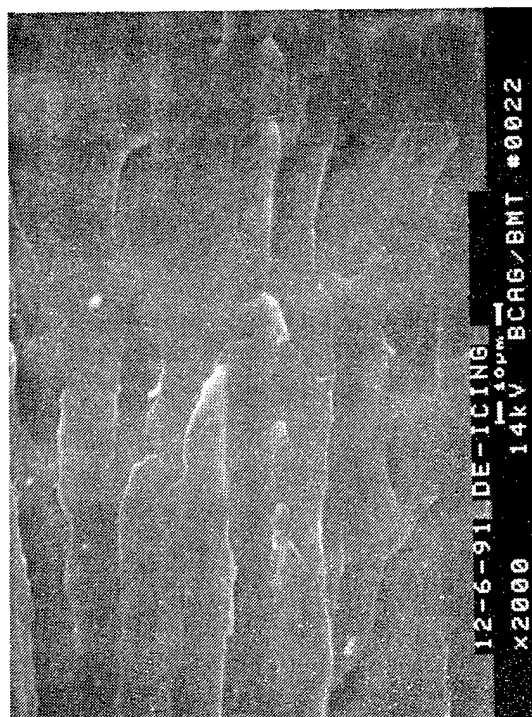
Figure 3.1-8. SEM Fractographs of 3501-6/AS4 Interlaminar Mode I Tension, Specimen Exposed to Deicing Fluid

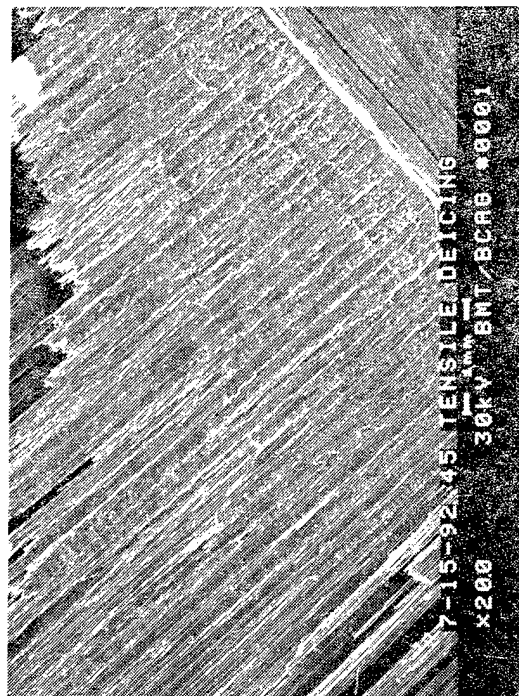
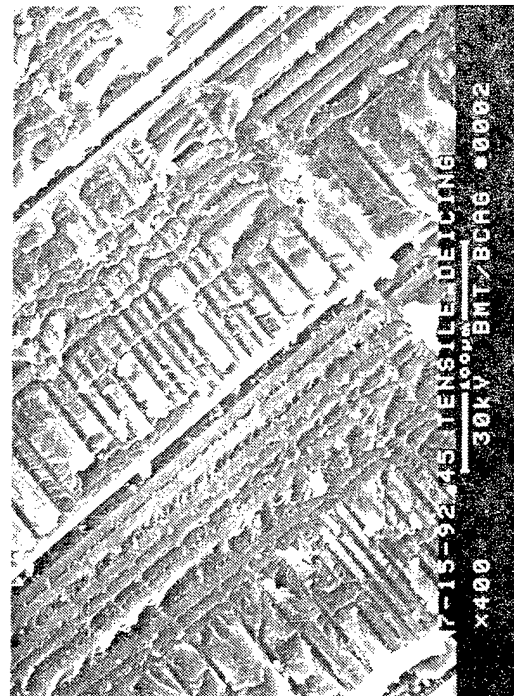
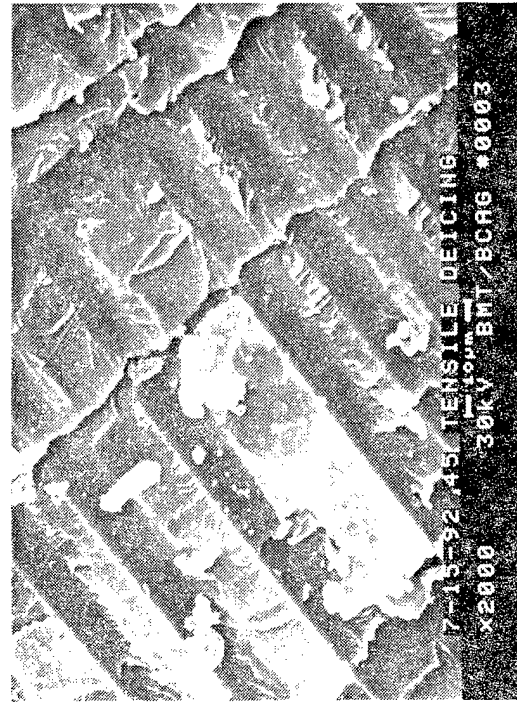
Figure 3.1-9. SEM Fractographs of a 3501-6/AS4 \pm 45 Tensile Specimen Exposed to Deicing Fluid, Interlaminar Surface

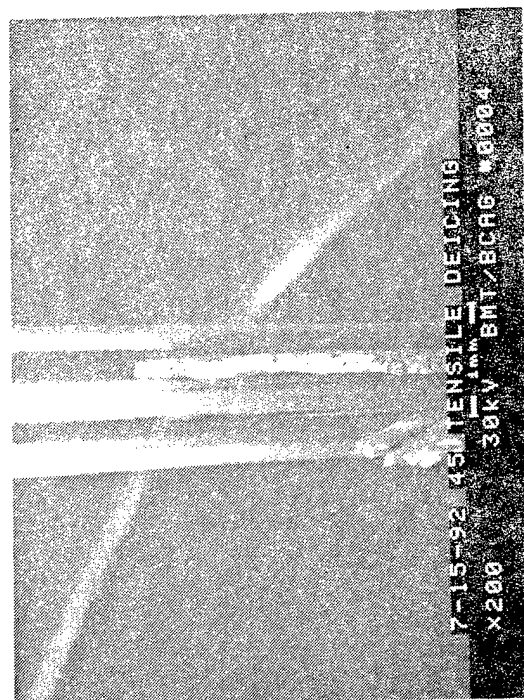
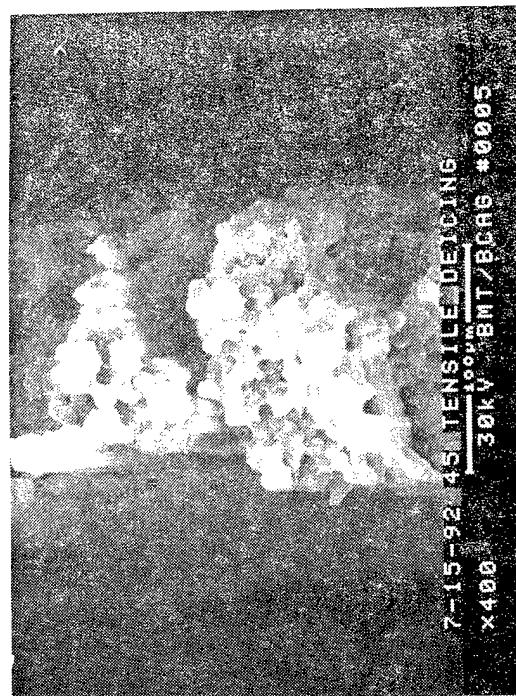
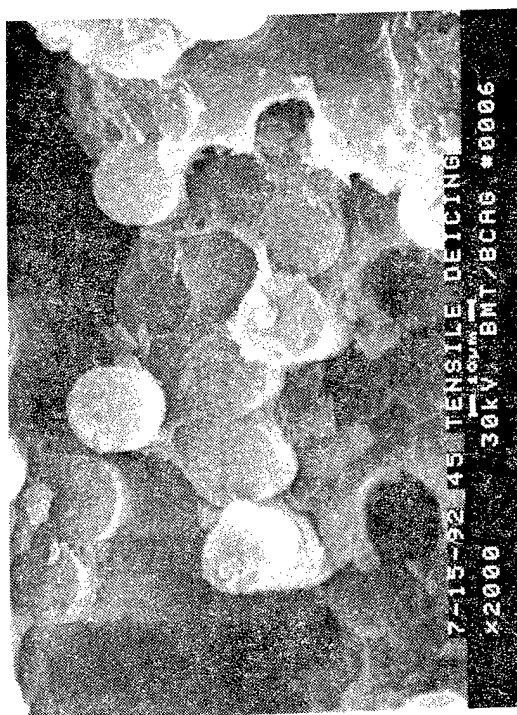
Figure 3.1-10. SEM Fractographs of a 3501-6/AS4 \pm 45 Tensile Specimen Exposed to Deicing Fluid, Translaminar Surface

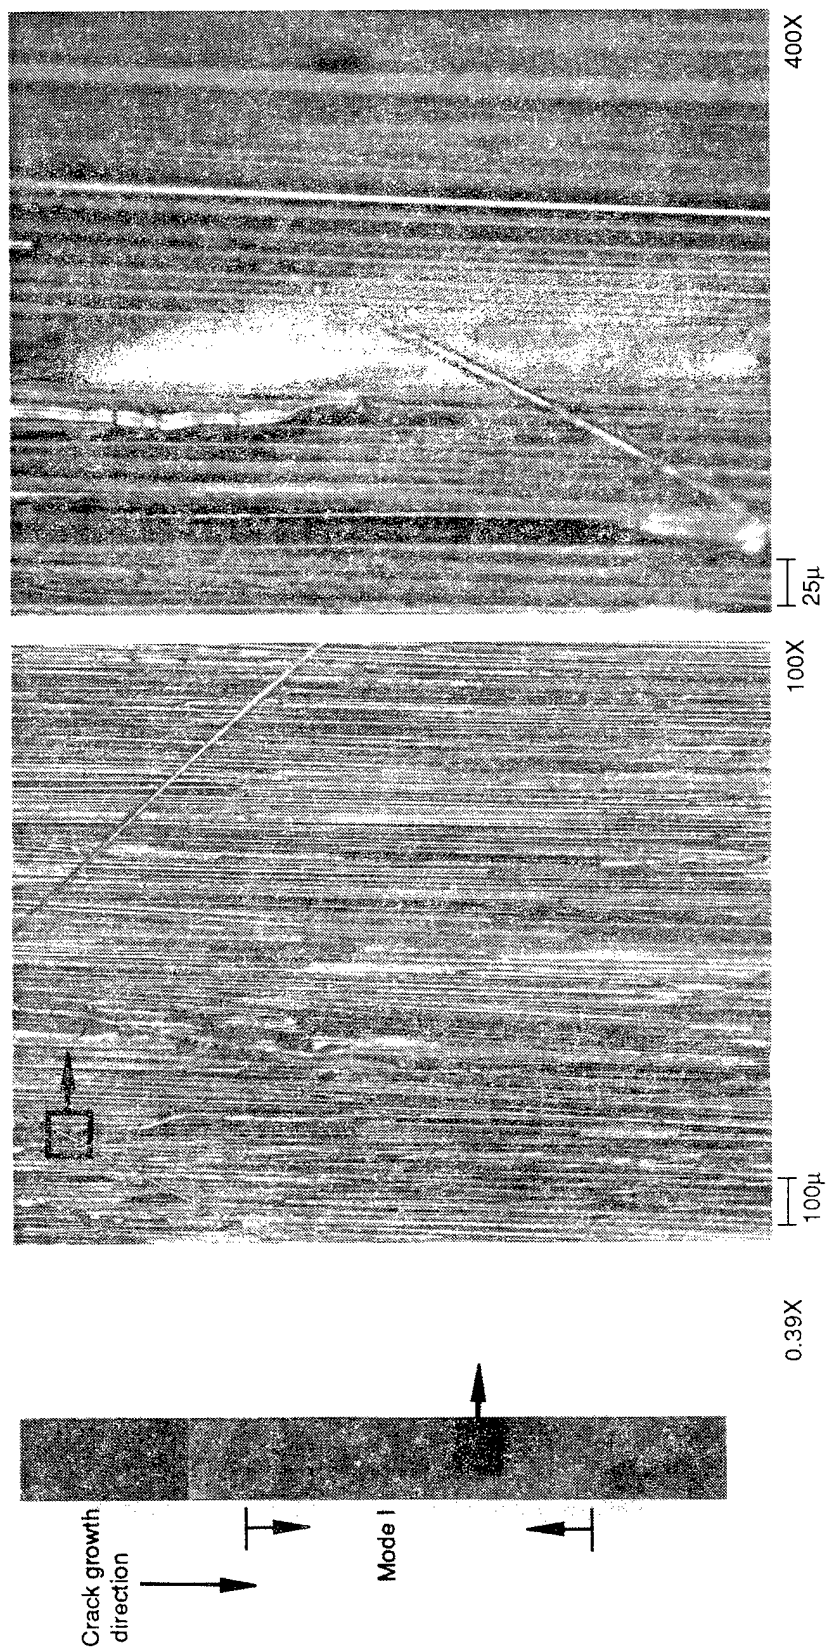
Figure 3.1-11. Optical Fractographs of 3501-6/AS4 Interlaminar Mode I Tension Specimen Tested at -20°F (Freezing Condition)

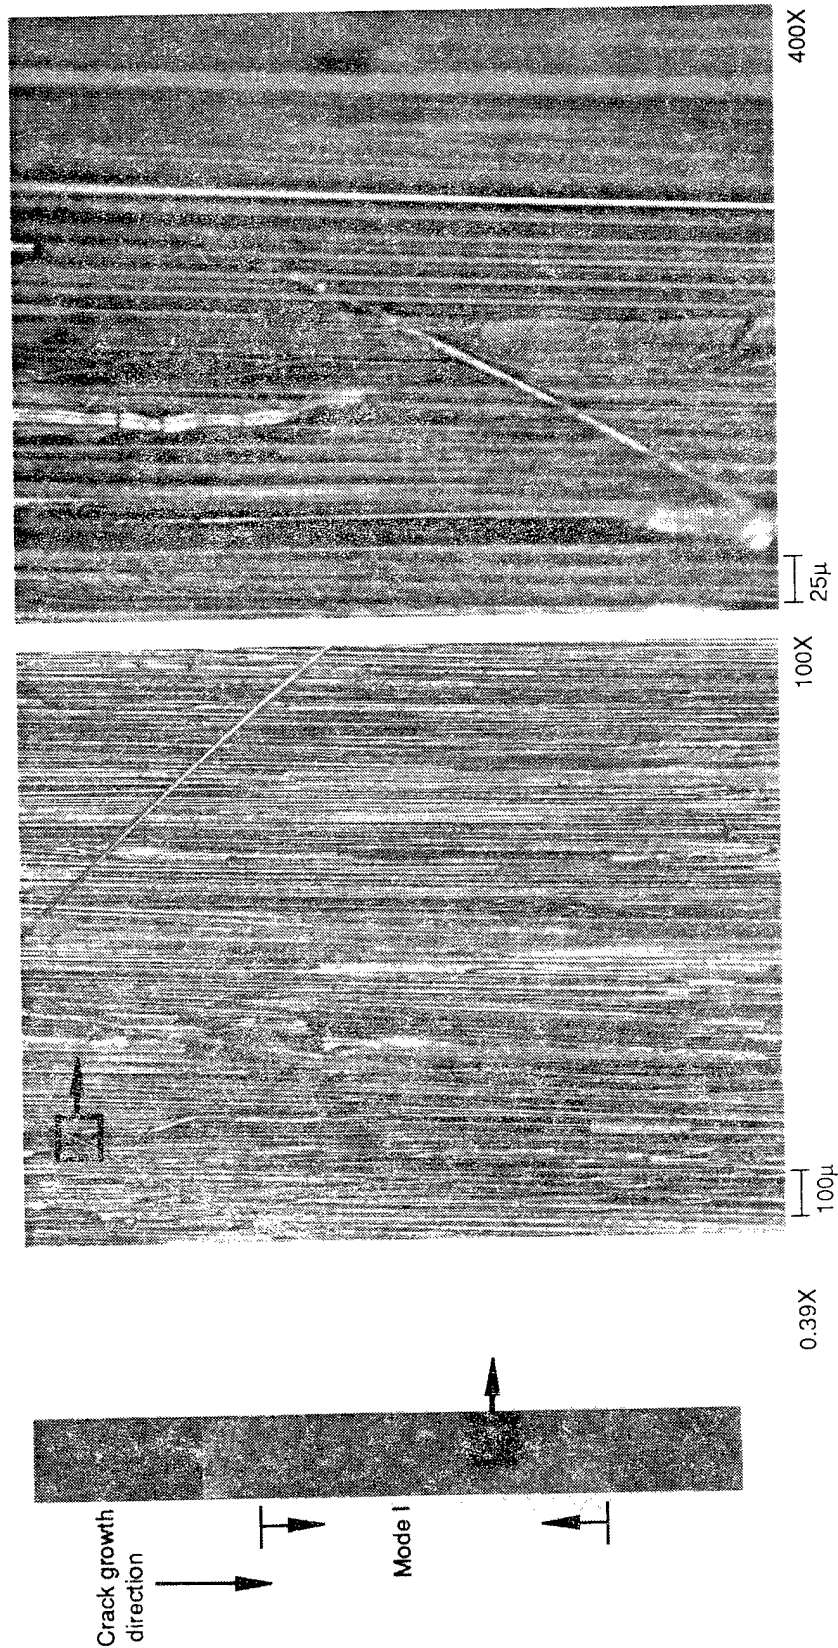
Figure 3.1-12. Optical Fractographs of 3501-6/AS4 Interlaminar Mode I Tension Specimen Tested at -20°F (Freezing Condition)

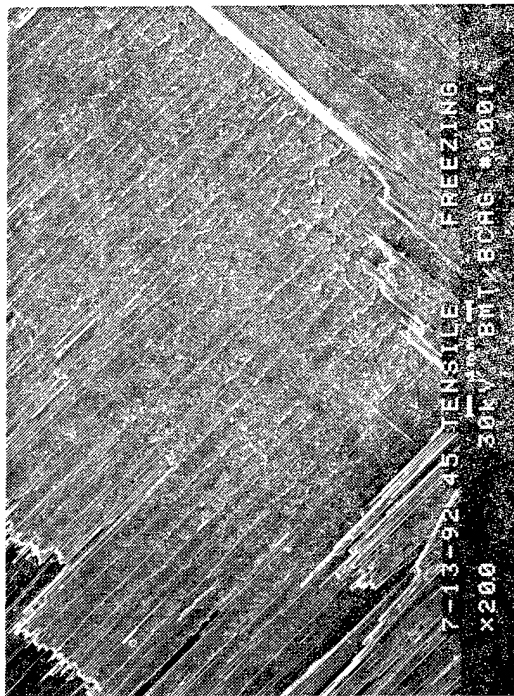
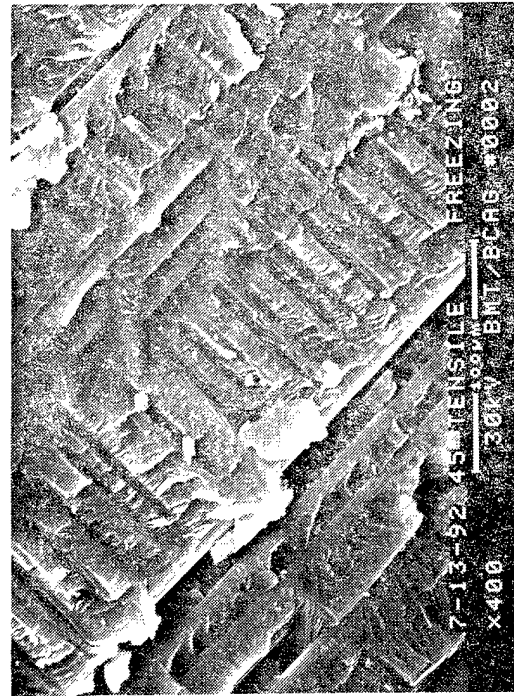
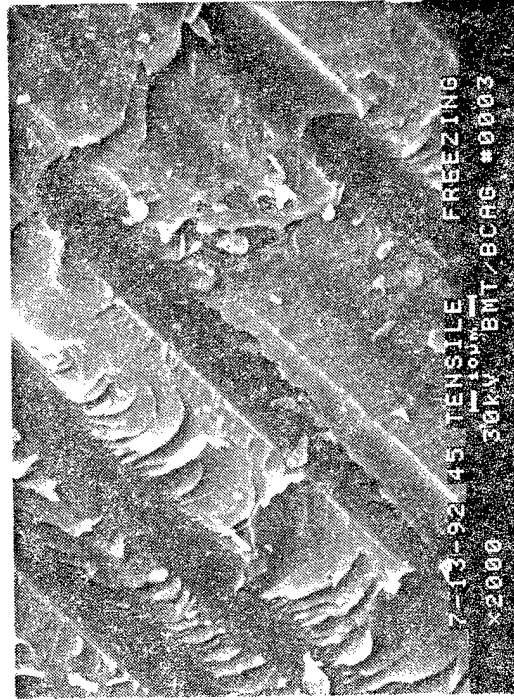
Figure 3.1-13. SEM Fractographs of a 3501-6/AS4 \pm 45 Tensile Specimen Tested at -20° F, Interlaminar Surface

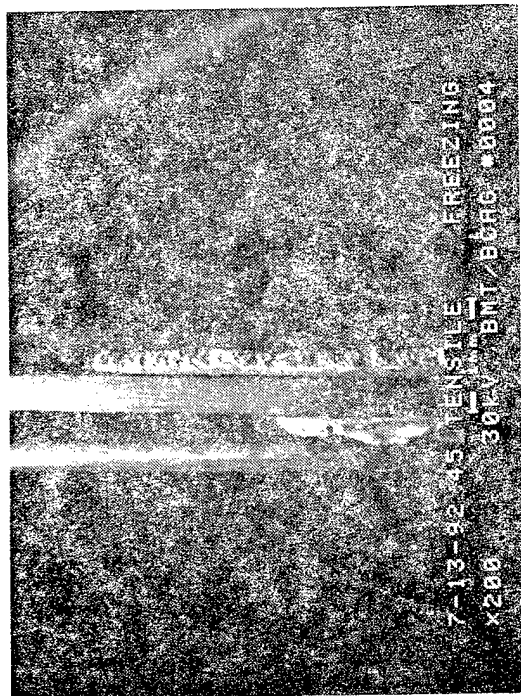
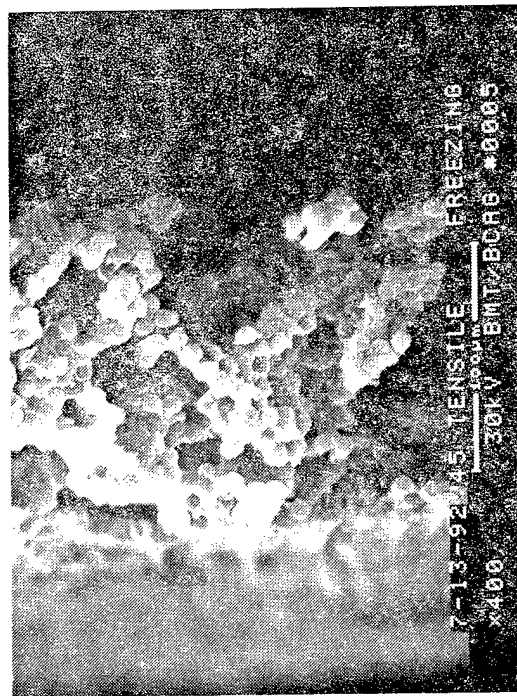
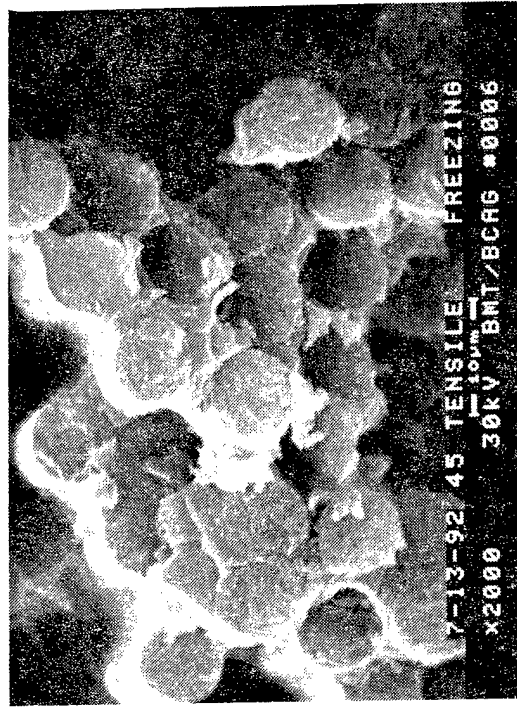
Figure 3.1-14. SEM Fractographs of a 3501-6/AS4 \pm 45 Tensile Specimen Tested at -20° F, Translaminar Surface

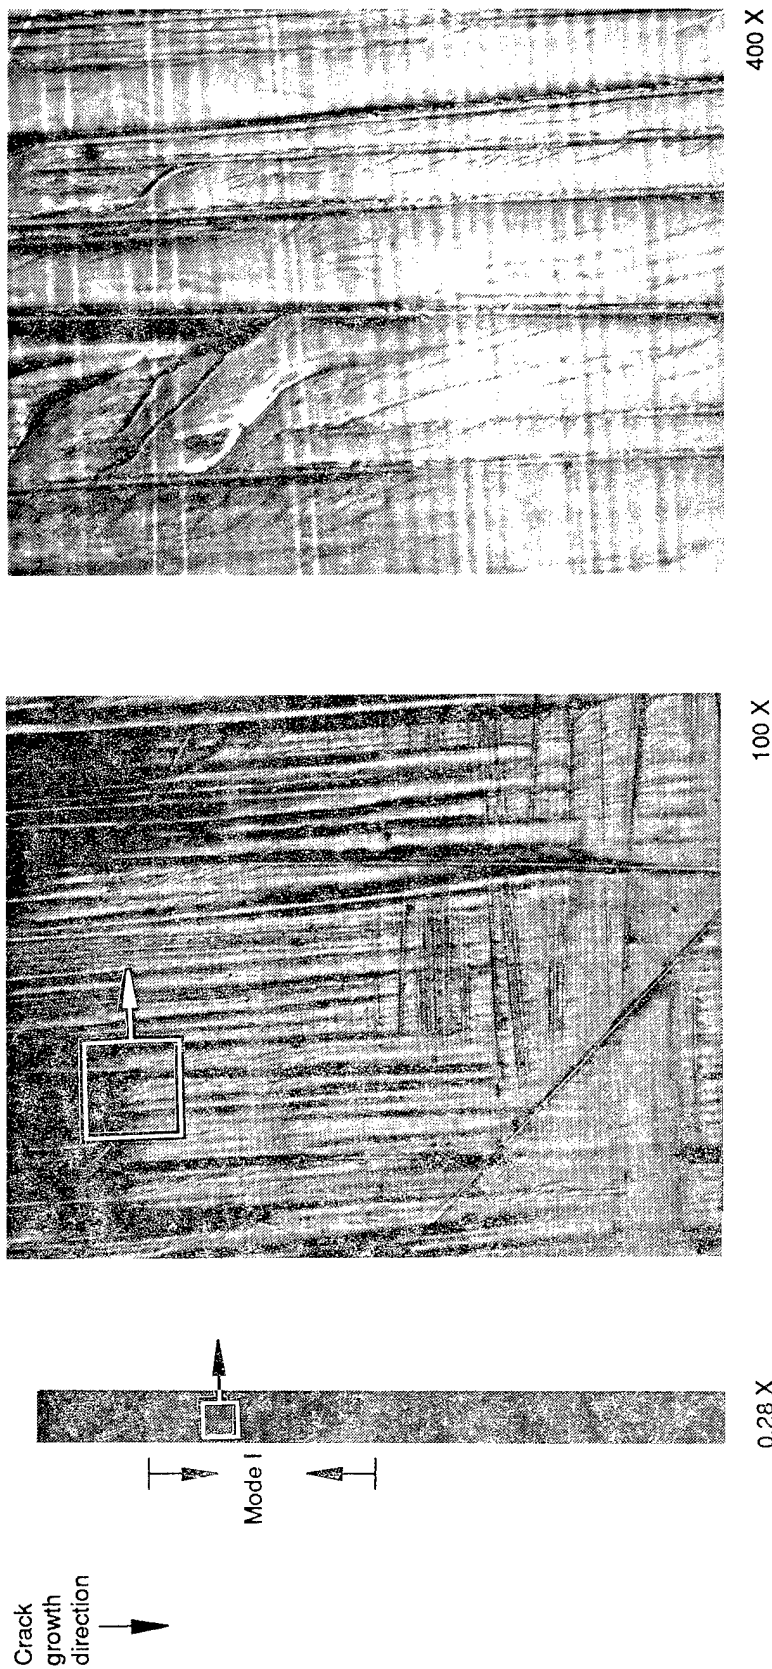
Figure 3.1-15. Optical Fractographs of 3501-6/AS4 Interlaminar Mode I Tension, Specimen Exposed to UV Radiation

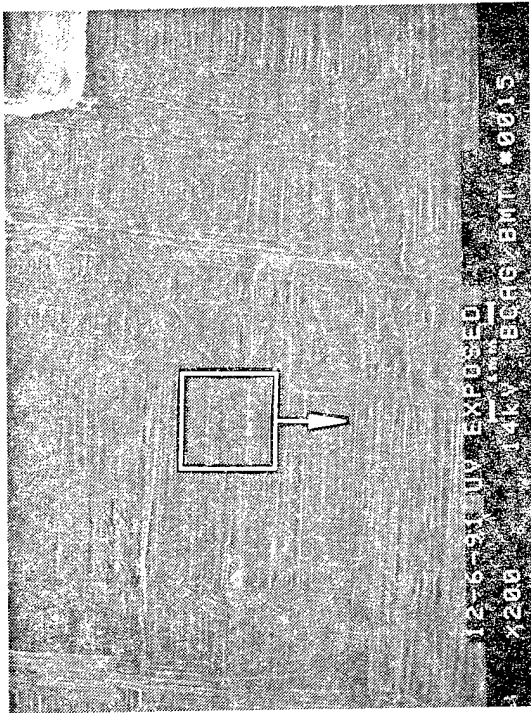
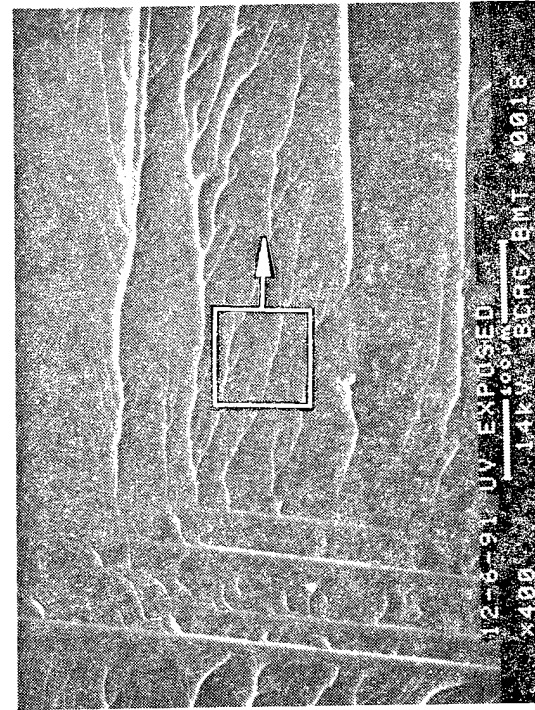
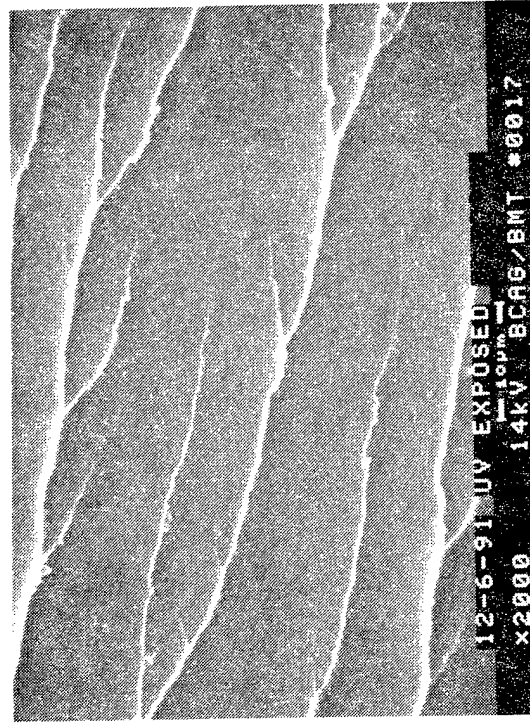
Figure 3.1-16. SEM Fractographs of 3501-6/AS4 Interlaminar Mode I Tension, Specimen Exposed to UV Radiation

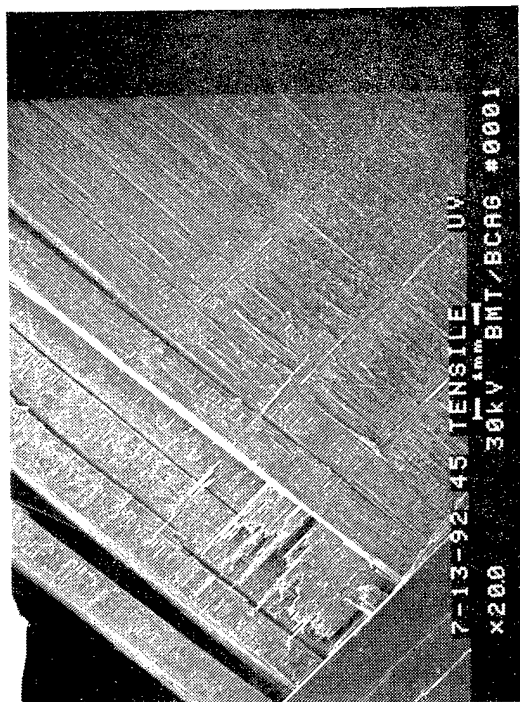
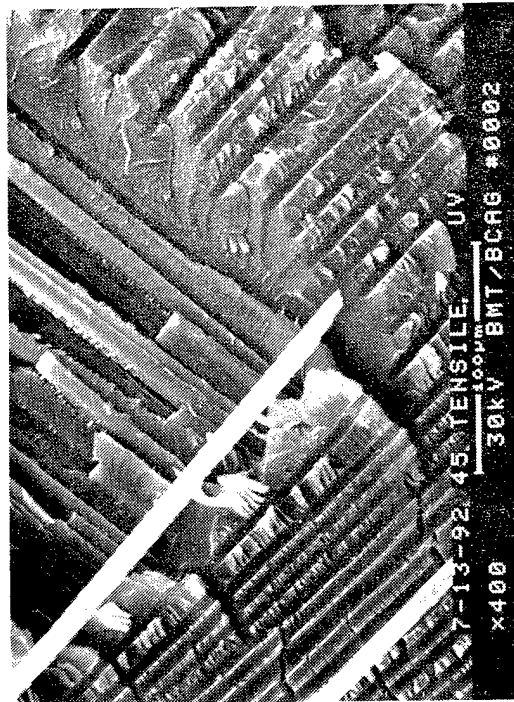
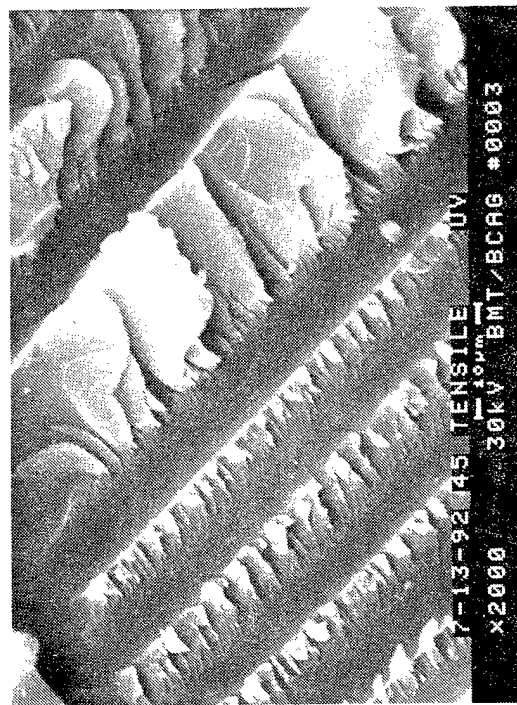
Figure 3.1-17. SEM Fractographs of a 3501-6/AS4 \pm 45 Tensile Specimen Exposed to UV Radiation, Interlaminar Surface
